INDOOR AIR QUALITY ASSESSMENT

**Atherton Hough Elementary School
1984 Sea Street
Quincy, Massachusetts**

Prepared by:
Massachusetts Department of Public Health
Bureau of Environmental Health Assessment
Emergency Response/Indoor Air Quality Program
March 2003

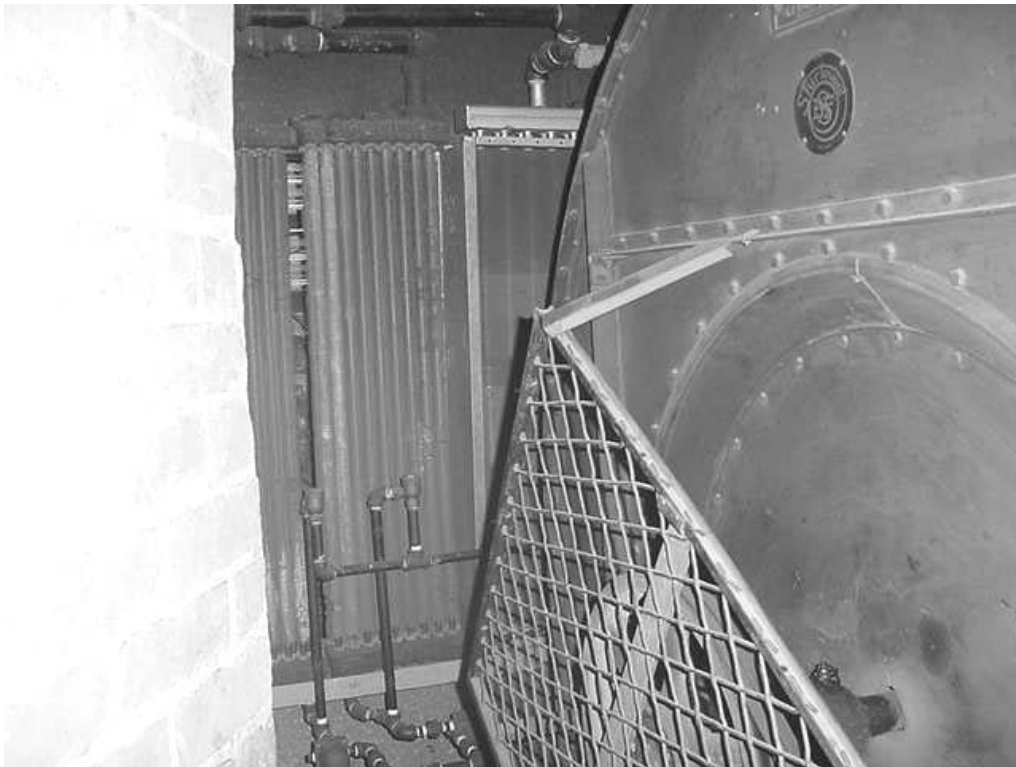
Picture 1

Fresh air is provided by an air handling unit (AHU) located in a large room on the ground floor that is connected to ductwork leading to air diffusers (see Picture 1). Fresh air is drawn into the building through a louvered vent in the basement (see Picture 2). Air is drawn through heating elements into a fan unit that distributes the air via wall mounted fresh air grilles in classrooms (see Picture 3). Classroom fresh air supply grilles are connected to the fan unit by ductwork located in the basement.

Large Fan Supplying Mechanical Ventilation System in 1911 Wing

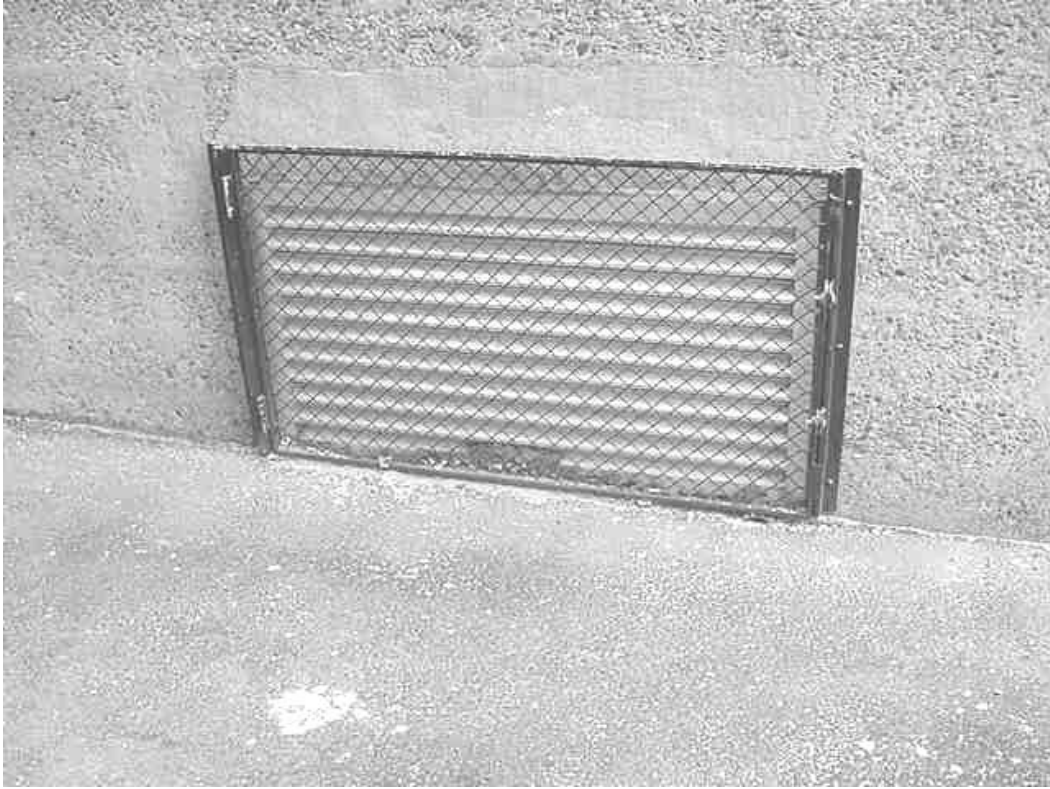
Picture 2

Fresh Air Intake

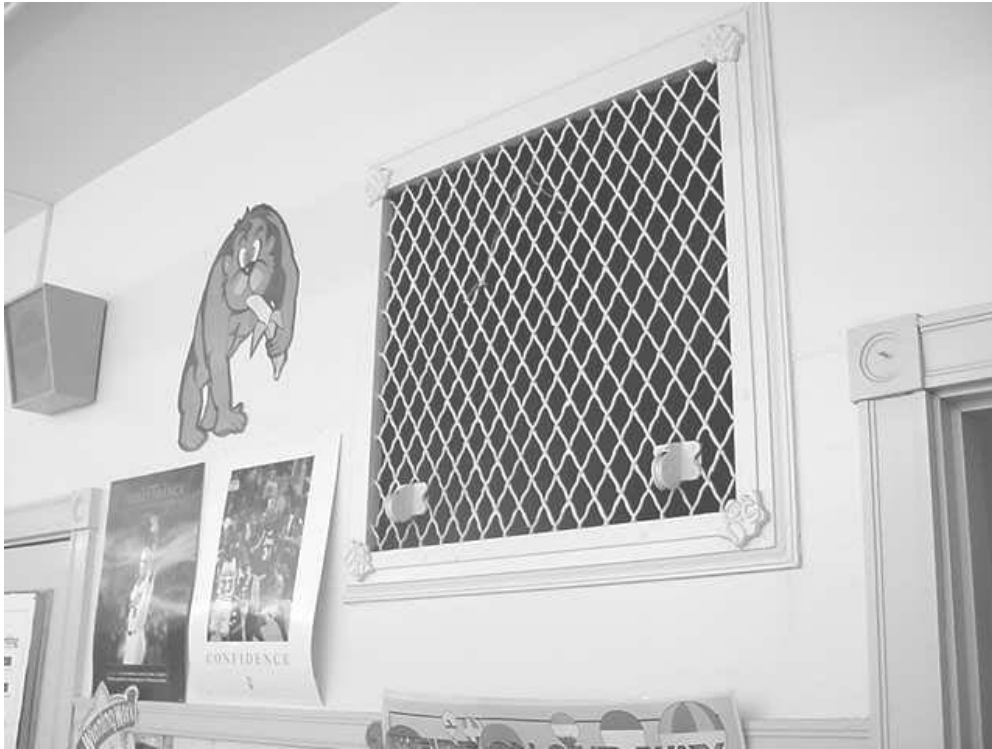
Picture 3

Supply Air Vent in Classroom

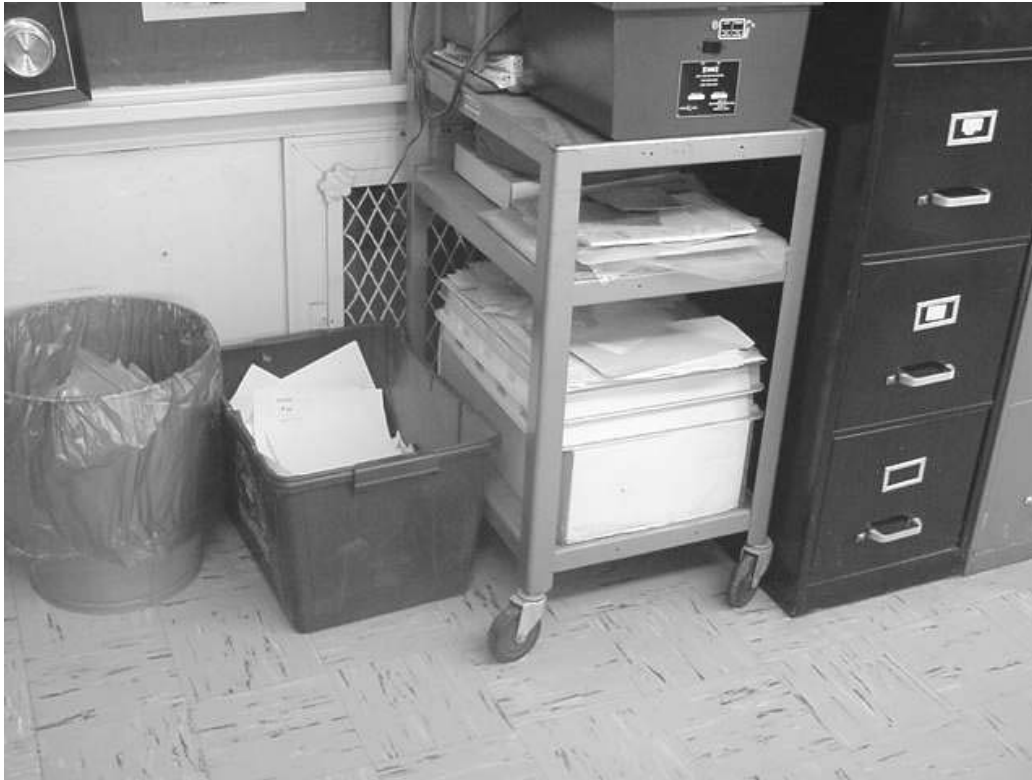
Picture 4

ventilation shafts to the basement heating elements. A number of these vents were obstructed by cabinets, bookcases and other items; some were intentionally sealed to prevent backdrafting (see Tables/Picture 4). As the heating elements draw air into the ducts, return air is drawn from the basement exhaust ventilation shafts. Negative pressure is created in these shafts, which in turn draw air into the exhaust vents of each classroom. The draw of air into these vents is controlled by a draw chain pulley system in classrooms and pneumatically controlled louvers at the exit of rooftop exhaust shafts (see Picture 5). This system was either deactivated or inoperable in certain areas. The exhaust/chimney cap pneumatic louver system in Picture 6 had been removed, leaving the chimney cap open to the elements (see **Other Concerns** section of this report).

Obstructed Exhaust Vent in Classroom

3. Repair/replace thermostats and control mechanisms (e.g. pull chains, louvers) for ventilation system where needed.
4. Remove all blockages from univents and exhaust vents to ensure adequate airflow.

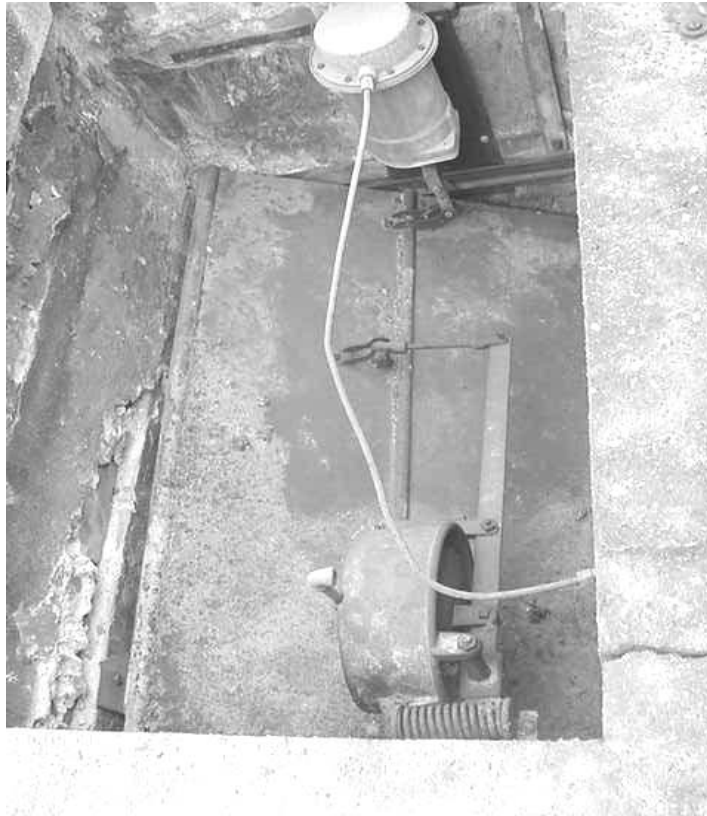
Picture 5

Pneumatically Controlled Exhaust Louvers on Rooftop Ventilation Shaft

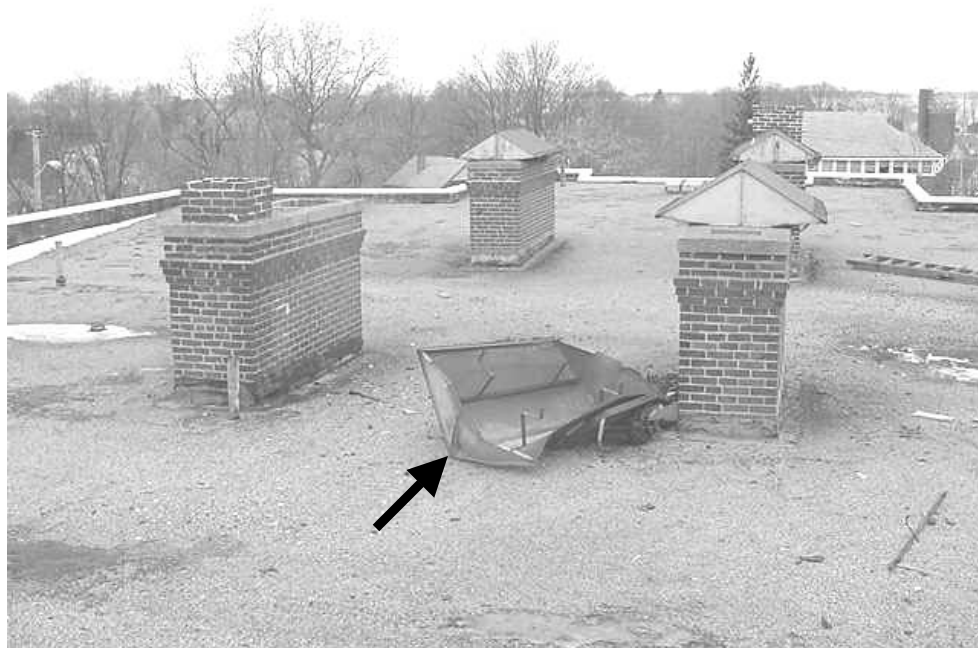
Picture 6

Several other conditions were noted during the assessment, which can affect indoor air quality. Unless functioning properly, the ventilation system can serve as a pathway for particulates and odors to migrate between areas of the building. The open shaft on the roof is a potential pathway for moisture, particulates and pests to enter the building.

Chimney Capped Removed From Ventilation Shaft

2. Repair/replace the chimney cap on the roof to prevent entry of pests, moisture, particulates and drafts. Cover the open cap in the meantime with wire mesh (chicken wire) to prevent entry.

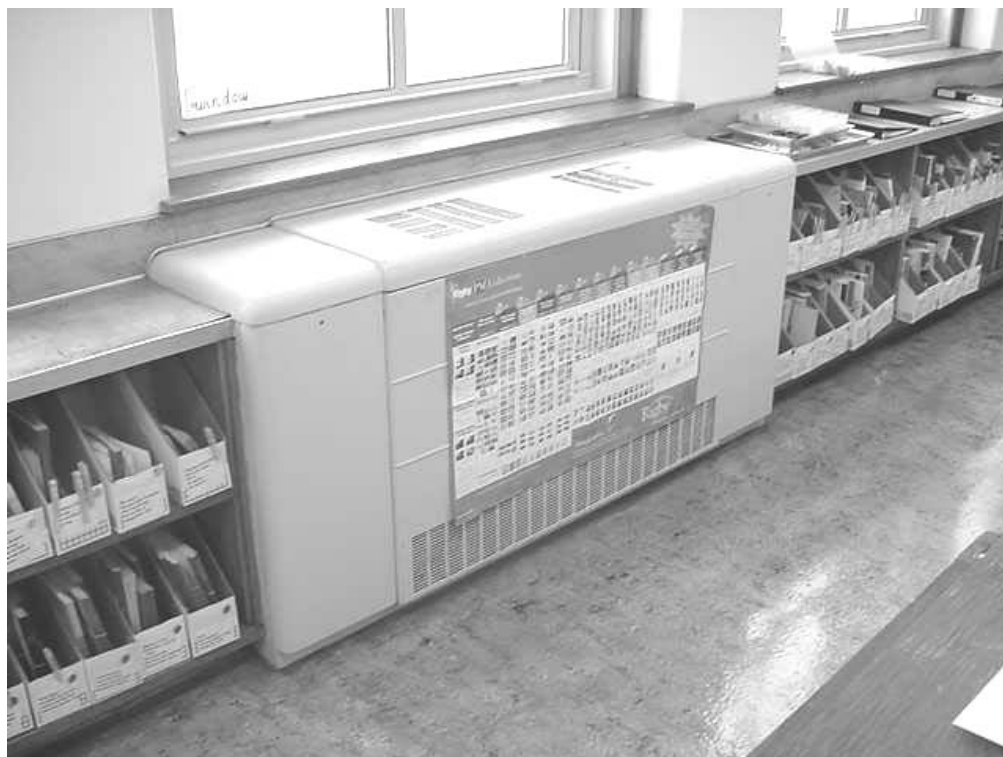
Picture 7

Fresh air in classrooms is supplied by a unit ventilator (univent) system (see Picture 7). Univents are designed to draw air from outdoors through a fresh air intake located on the exterior wall of the building (see Picture 8) and return air through an air intake located at the base of each unit (see [Figure 1](#)). Fresh and return air are mixed, filtered, heated and provided to classrooms through a fresh air diffuser located on the front of the unit. Univents were found deactivated in a few areas, which prevents a continuous source of outside air to provide ventilation. Obstructions to airflow, such as paper and boxes stored on univent air diffusers and desks in front of univent return vents, were also noted in classrooms (see Picture 9). In order for univents to provide fresh

Classroom Univent

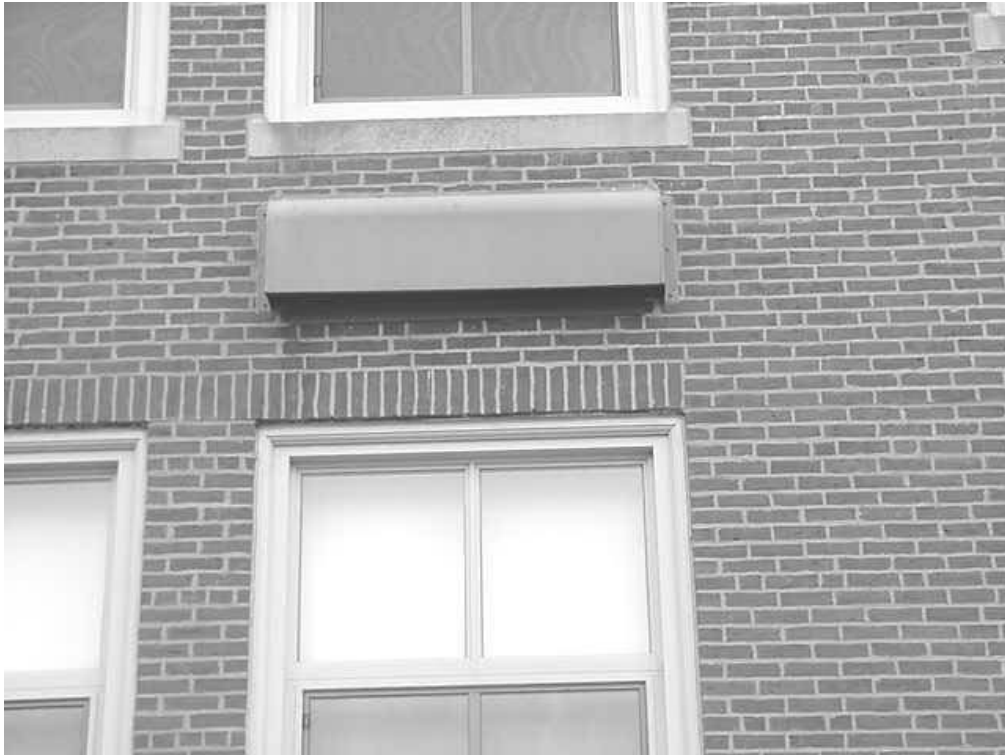
Picture 8

Covered Air Intake for Classroom Univent

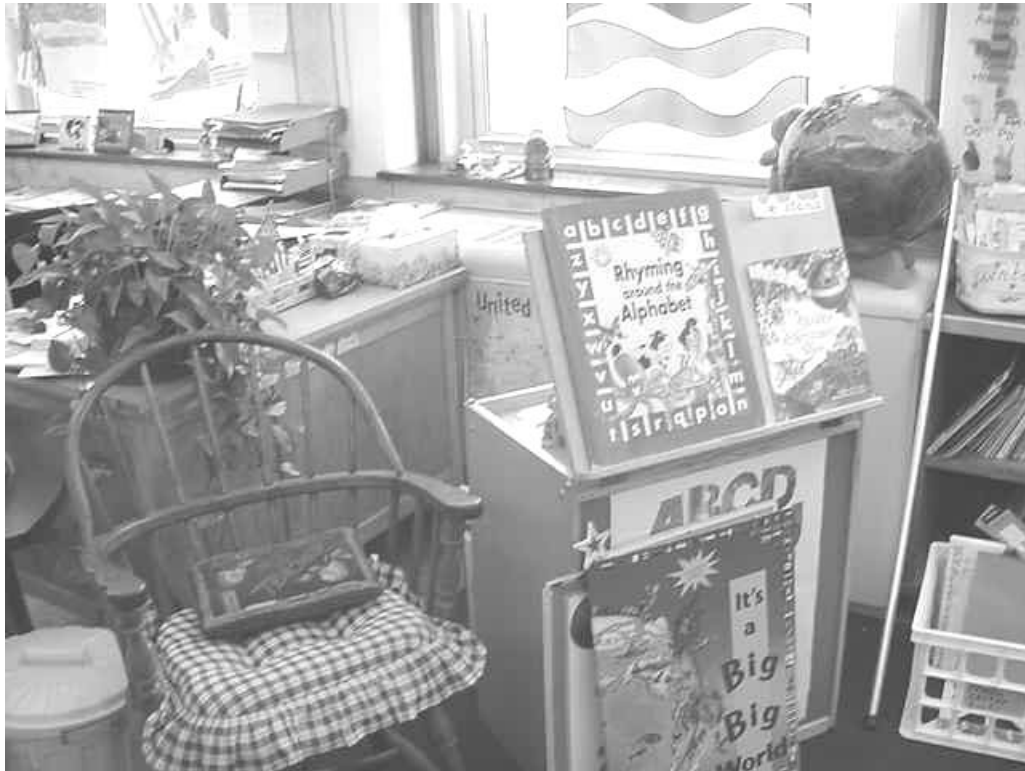
Picture 9

air as designed, univent air diffusers and return vents must remain free of obstructions.

Various Items Obstructing Airflow of Classroom Univent

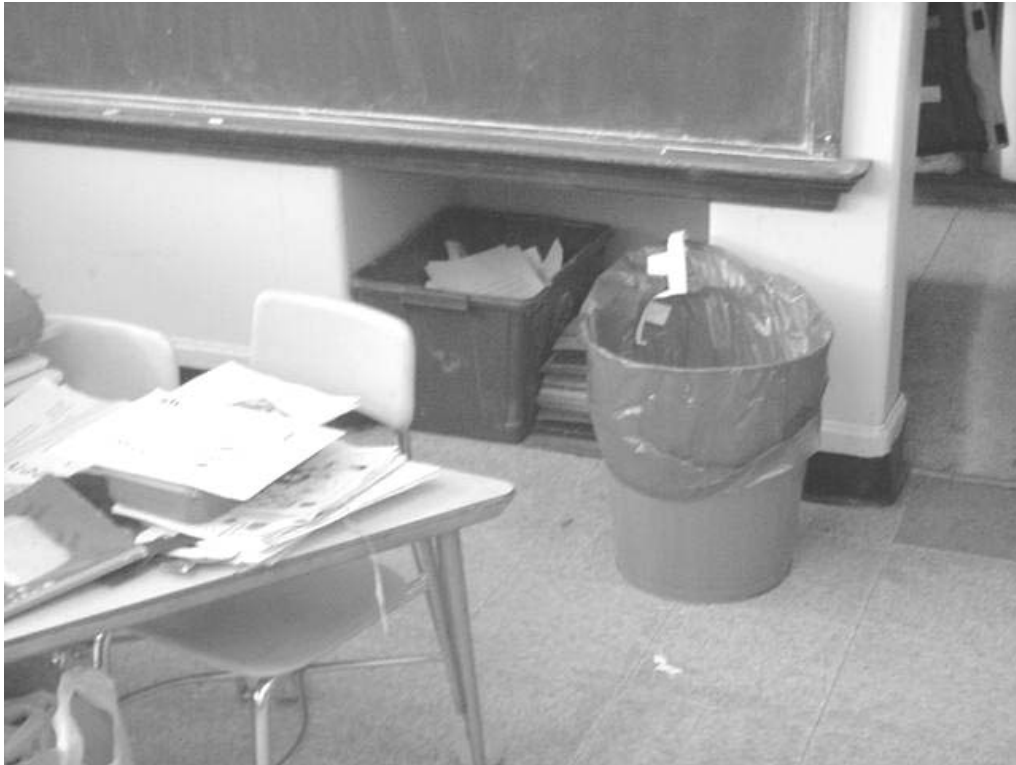
Picture 10

Exhaust ventilation is provided by a mechanical system, which draws air into an ungrated hole, located at floor level in classrooms. Airflow is controlled by a flue located inside the duct. This system appeared to be off in some classrooms surveyed. In addition, these ungrated holes were being used to store recycling bins, crates, books, boxes and files in a number of areas (see Picture 10). As with the univents, in order for exhaust ventilation to function as designed, exhaust fans must be activated and remain free of obstructions.

Exhaust Cubby in Classroom, Note Materials Stored Within

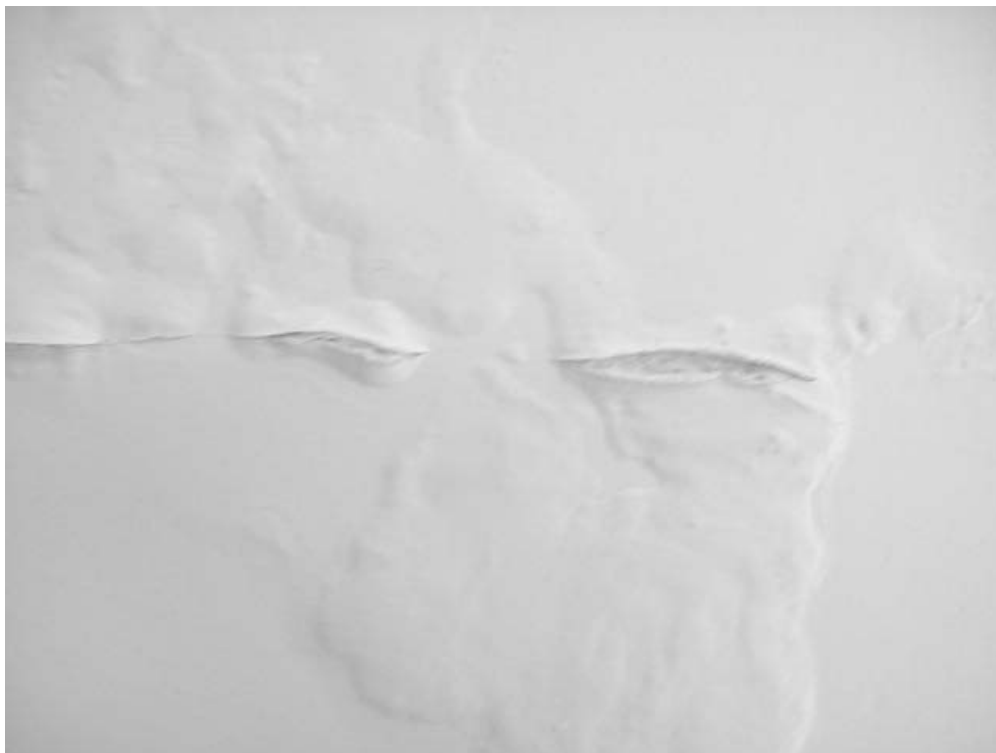
Picture 11

Water damaged wall plaster and efflorescence (i.e., mineral deposits) were observed in a few areas (see Picture 11), which indicates a current or historic water penetration problem. Efflorescence is a characteristic sign of water intrusion. As moisture penetrates and works its way through mortar around brick it leaves behind these characteristic mineral deposits. This condition indicates that water from the exterior is penetrating into the building.

Efflorescence Peeling Paint in Classroom

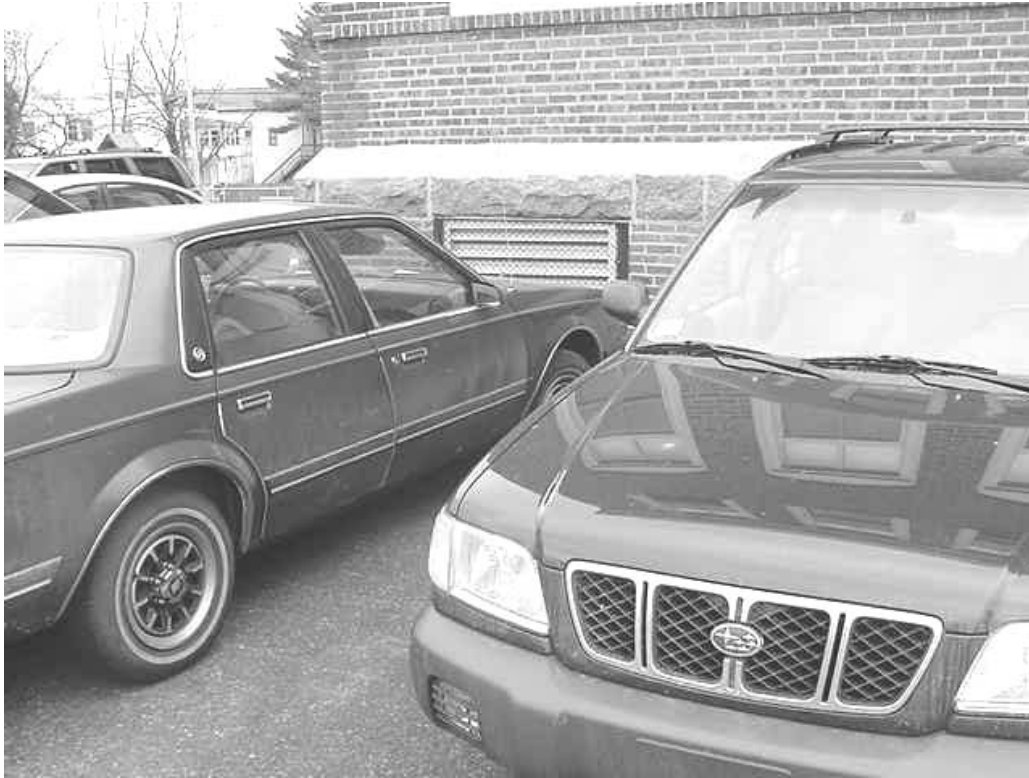
Although no complaints of vehicle exhaust odors have been reported to MDPH in relation to the building, the potential for entrainment exists. Picture 12 illustrates the close proximity of the employee parking lot to the building and the potential for vehicle exhaust to be pulled into the univent fresh air intakes (called entrainment). Idling vehicles can result in the entrainment of vehicle exhaust into the building, which may, in turn, provide opportunities for exposure to compounds such as carbon monoxide. M.G.L. chapter 90 section 16A prohibits the unnecessary operation of the engine of a motor vehicle for a foreseeable time in excess of five minutes (MGL, 1996).

Vehicles Parked near Fresh Air Intake

11. Seal around univent in classroom 15 to prevent drafts.
12. Consider relocating employee parking from areas in close proximity to air intake vents.
If not feasible, post signs in parking area instructing employees not to back in to avoid entrainment of vehicle exhaust to remind them of Massachusetts anti-idling laws (MGL, 1996).
